From: Chris Collyer chris@playsafeplaygrounds.co.uk
Subject: RE: Stedham inspection
Date: 3 September 2018 at 11:08
To: Jane Crawford clerk@stedhamwithiping-pc.gov.uk

PLAYSAFE PLAYGROUNDS Ltd.
INSPECTION WORKSHEET

CLIENT ORGANISATION: Stedham Parish Council	
SITE ADDRESS: Common View Play Area, Stedham	
INSPECTION CARRIED OUT BY: Chris Collyer	INSPECTION DATE: 25/08/2018
CLIENT CONTACT: Jane Crawford	CLIENT CONTACT No.: 01730 812177

CLIENT ORGANISATION: Stedham Parish Council	
SITE ADDRESS: The Green Play Area, Stedham	
INSPECTION CARRIED OUT BY: Chris Collyer	INSPECTION DATE: 25/08/2018
CLIENT CONTACT: Jane Crawford	CLIENT CONTACT No.: 01730 812177

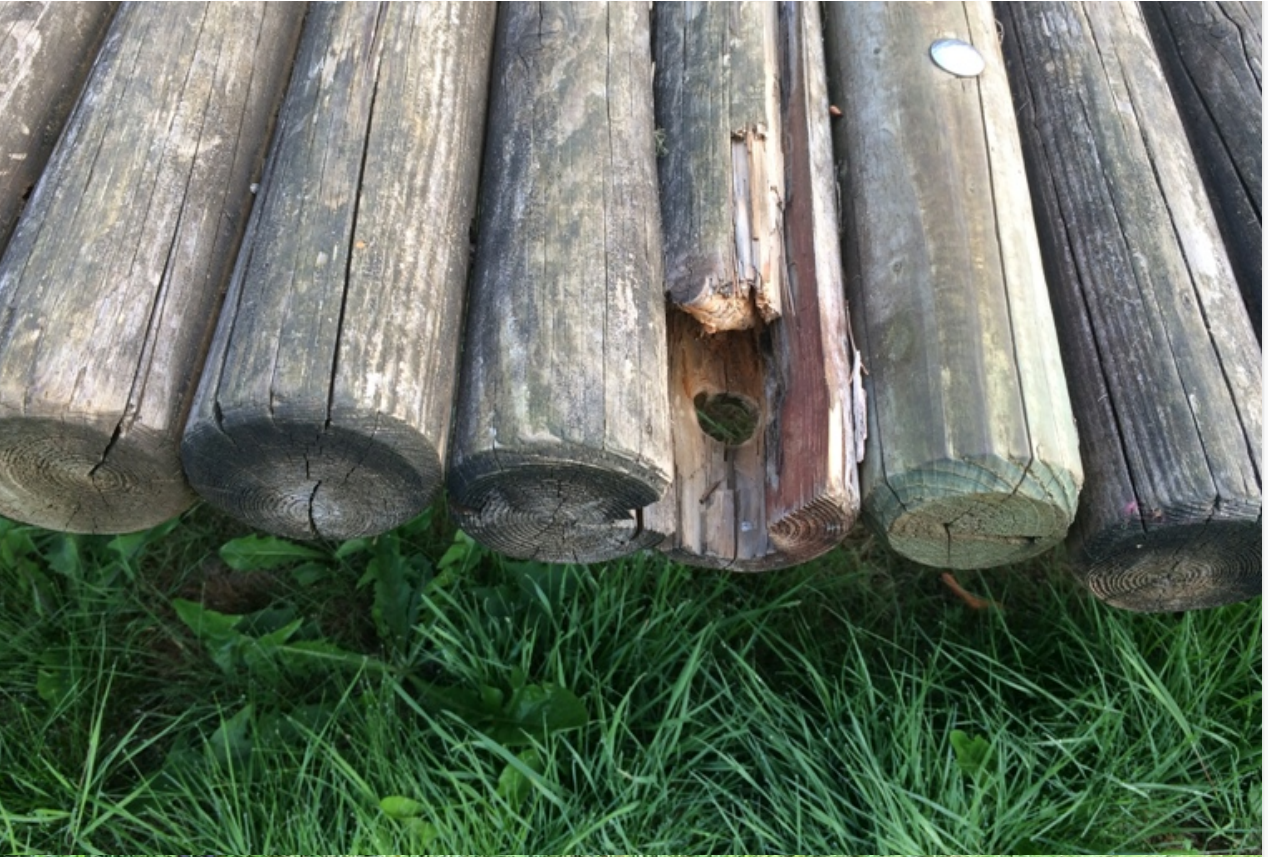
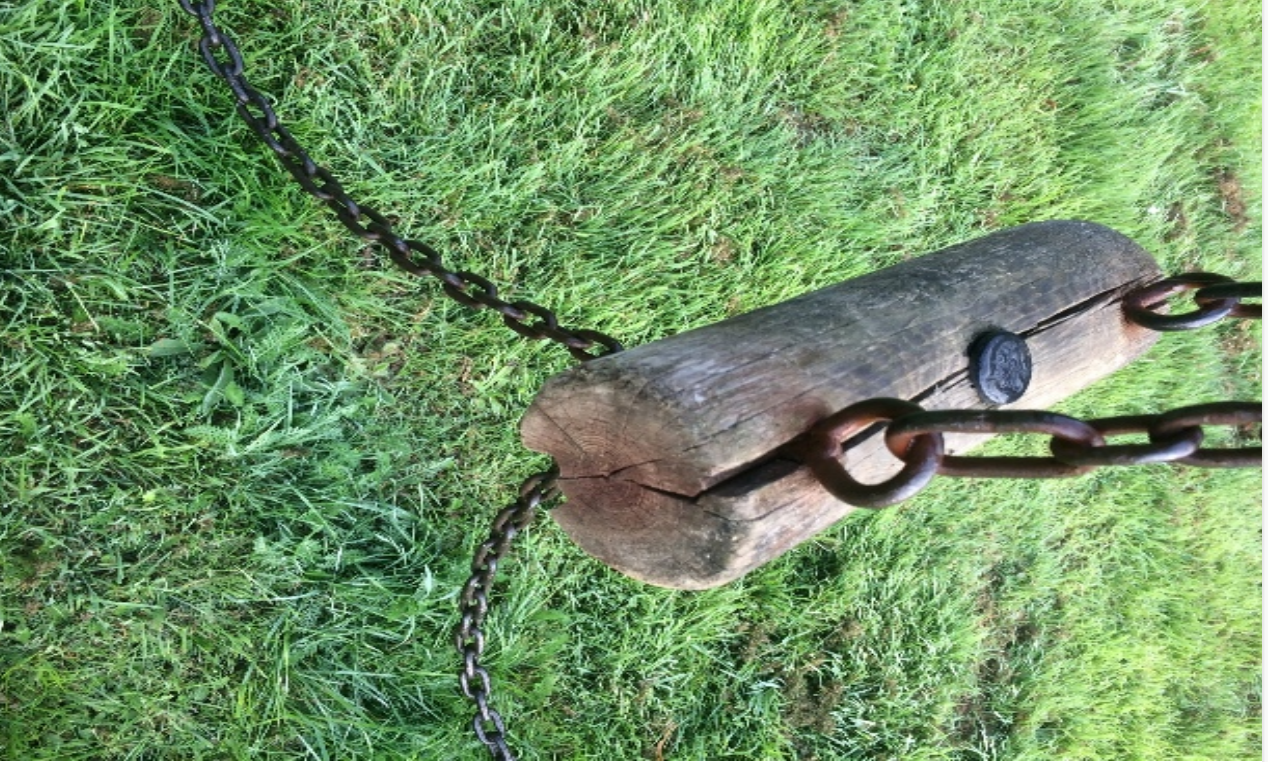
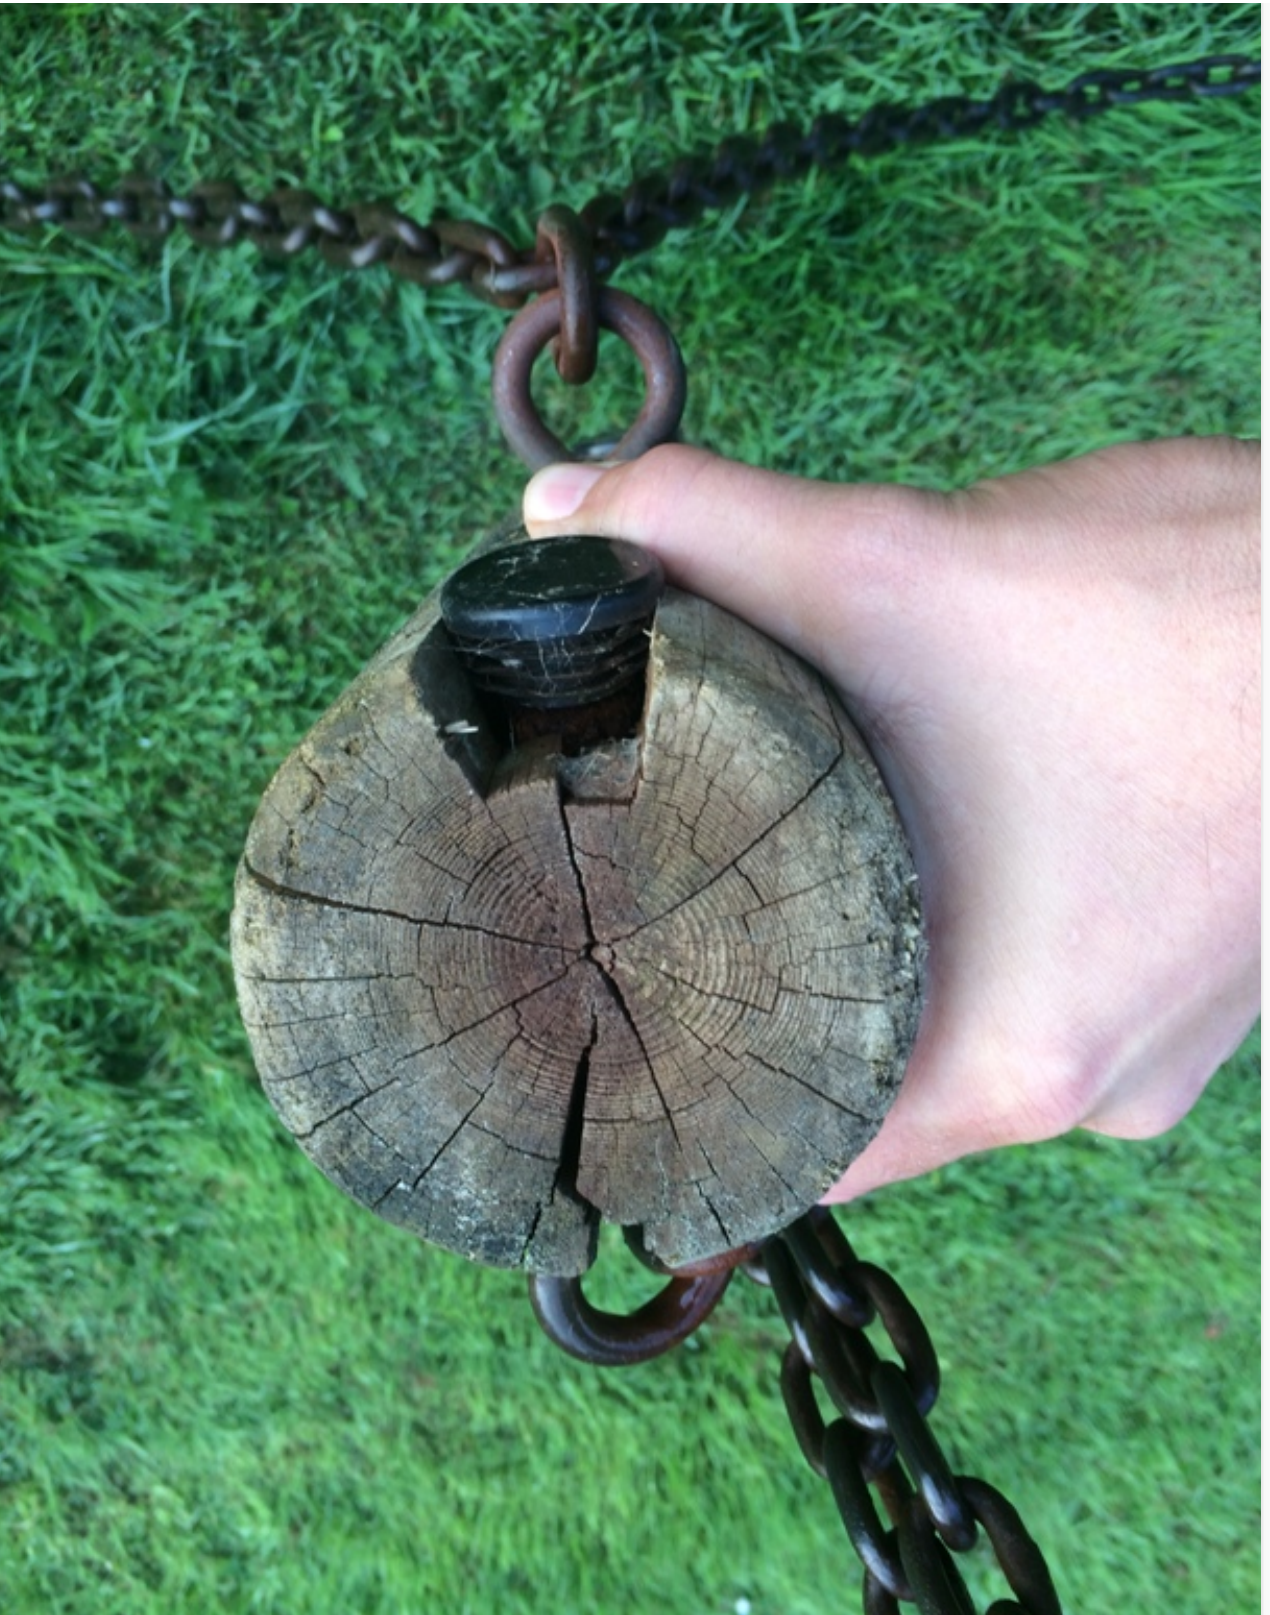
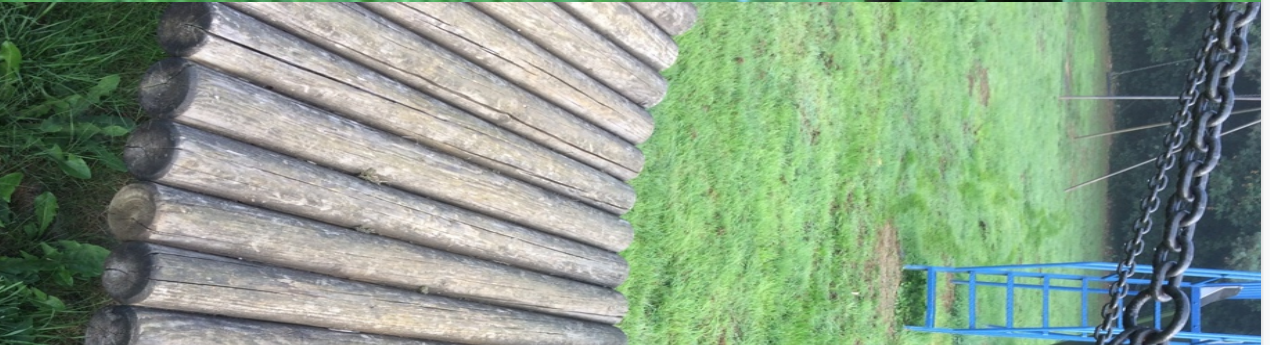
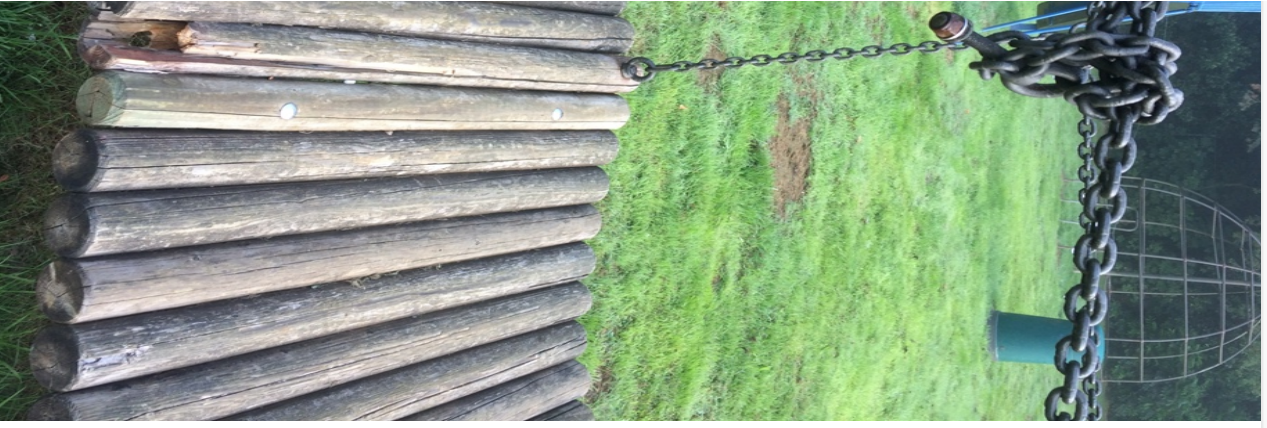
- Log on log chain needs to be replaced - see attached pictures;
- Log on large suspension bridge needs to be replaced - see attached pictures;

Let me know if you need us to make these repairs and we will get things moving as soon as possible.
